CALIFORNIA DIVISION OF MINES AND GEOLOGY

FAULT EVALUATION REPORT FER-138

October 19, 1982

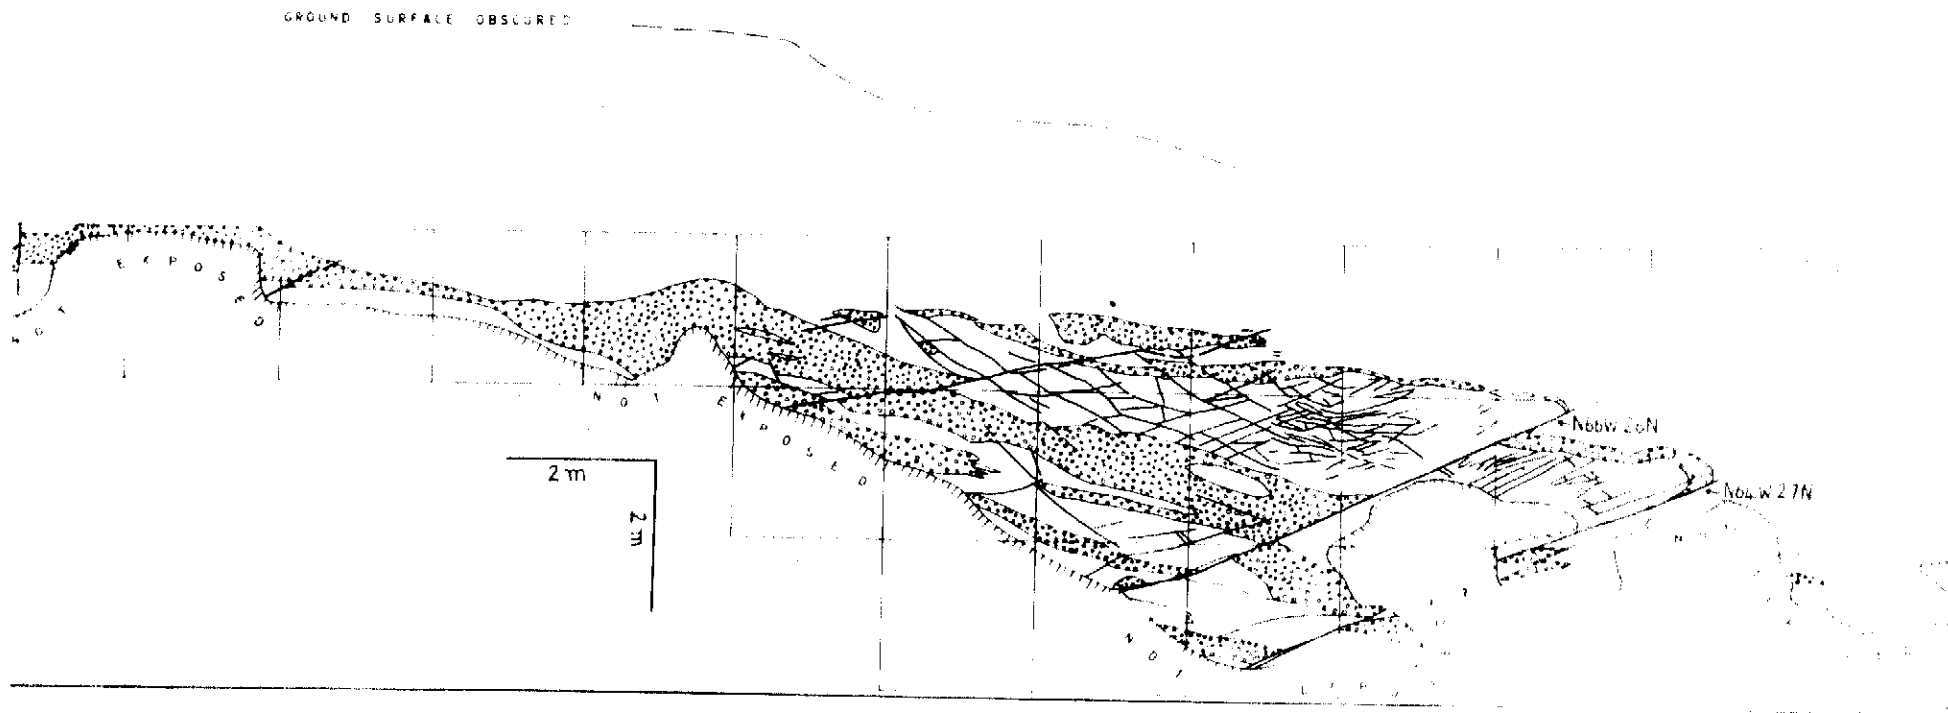
FER-138. Figure 2. Log of fault exposure at Anderson Ranch (Trinidad fault). Log from Rust, 1982.

In early 1979, a northeast-dipping, low angle ( $26^{\circ}$ - $27^{\circ}$ ) zone of thrust faults was discovered exposed in a sea cliff north of Trinidad (Figure 2) (Rust, 1982). The exposure of this fault zone, referred to as the Trinidad

The observations of Rust (1982, included herein as Figure 2) at Anderson Ranch (Figure 4A), were partially verified in October 1981 and September 1982. The terrace deposits are clearly displaced along at least one low-angle thrust fault, and terrace gravels have clearly been displaced over post-terrace colluvium. The pattern of conjugate shears in the upper plate was also quite evident. The principal thrust faults observed at the Anderson Ranch locality appear to be on strike with the base of a well-defined scarp that crosses the Patricks Point terrace. To the southeast of Trinidad, along Trinidad Bay and Luffenholz beach, no convincing exposures of faults were observed; however, the roadcuts in this area are often covered with vegetation.

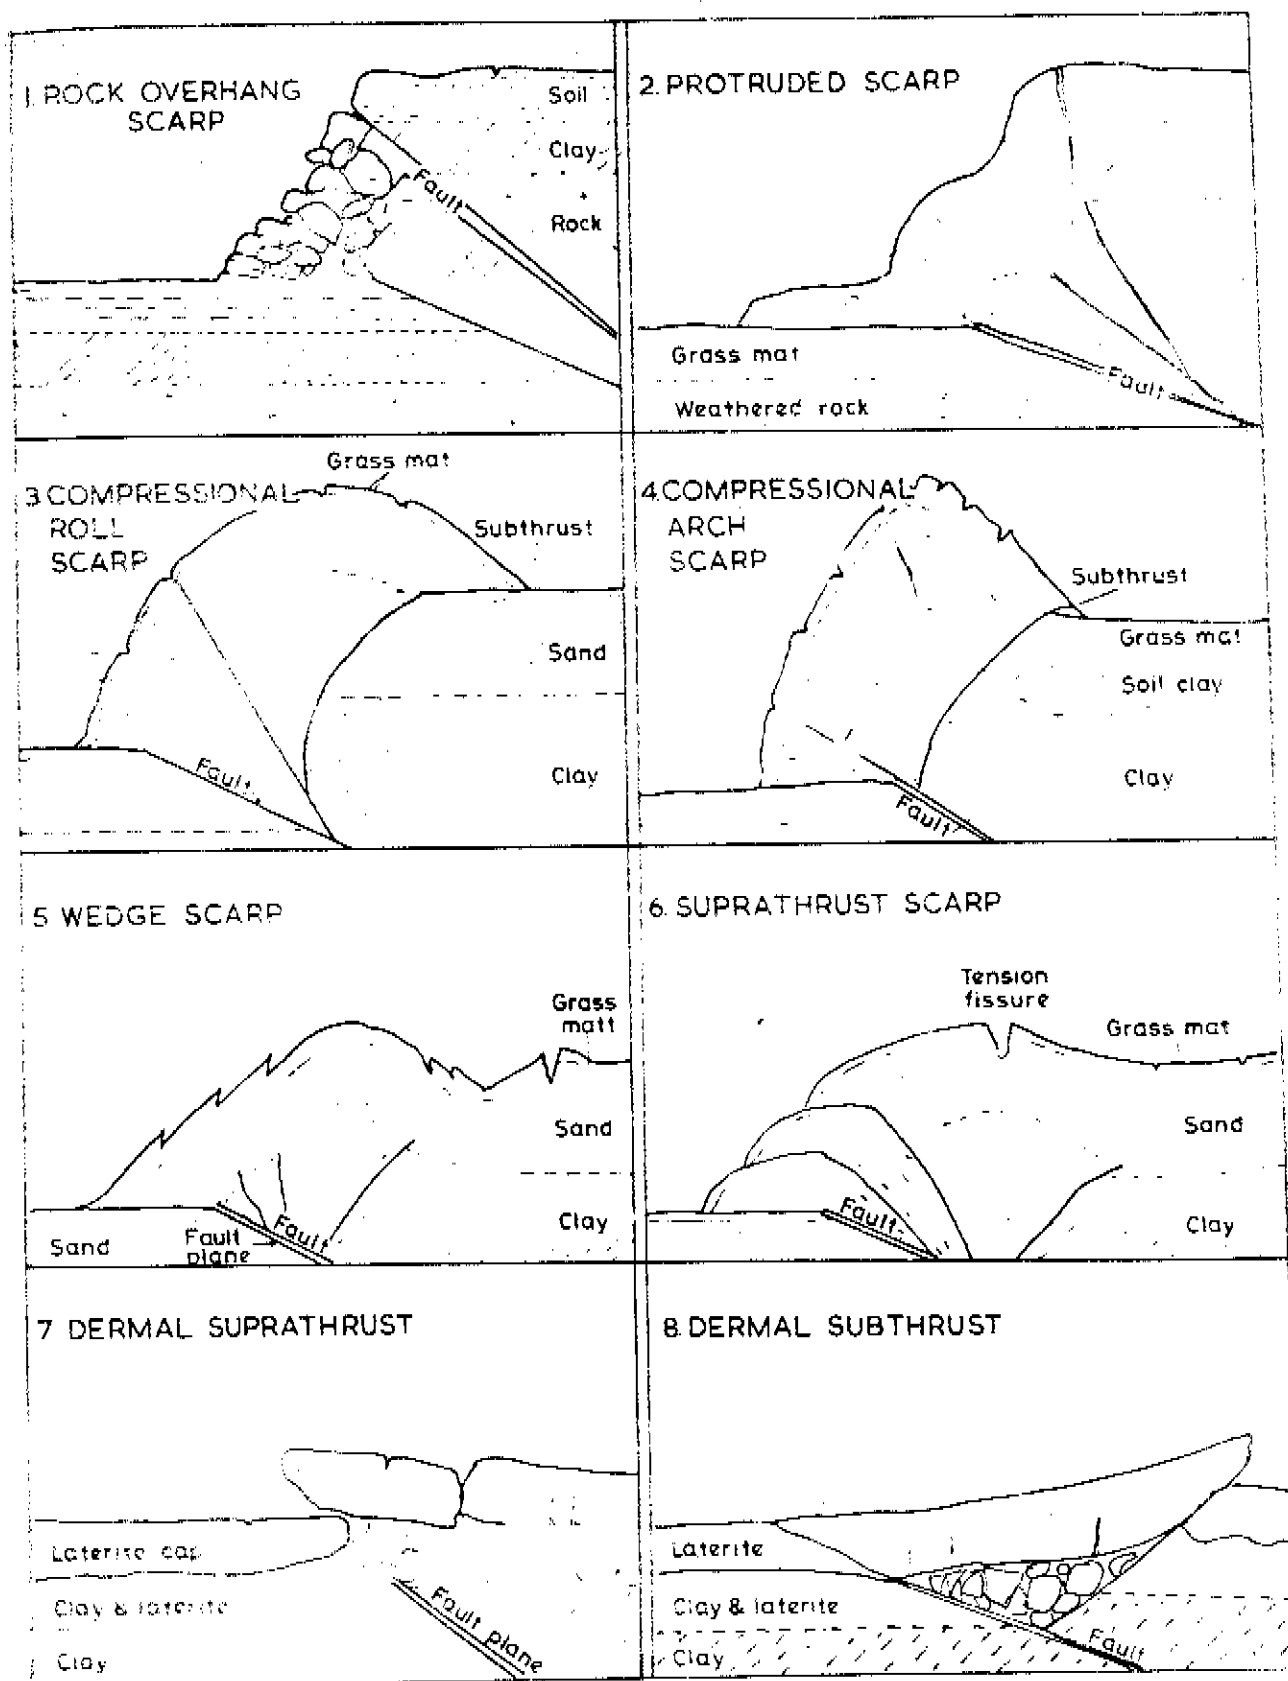
Fig. 5. Eight different types of scarps along McKerrin Road scarp showing how the shape of the scarp is controlled by the type of the soil cover and by the degree of weathering. Horizontal and vertical scales are arbitrary and the scarp is about 10 m high in all sections.

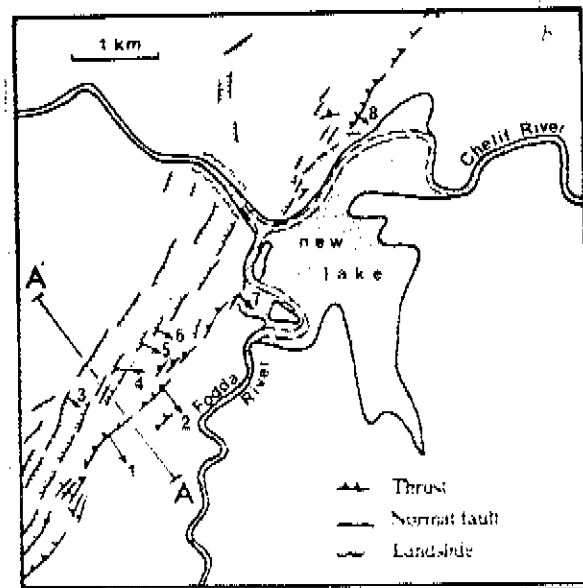
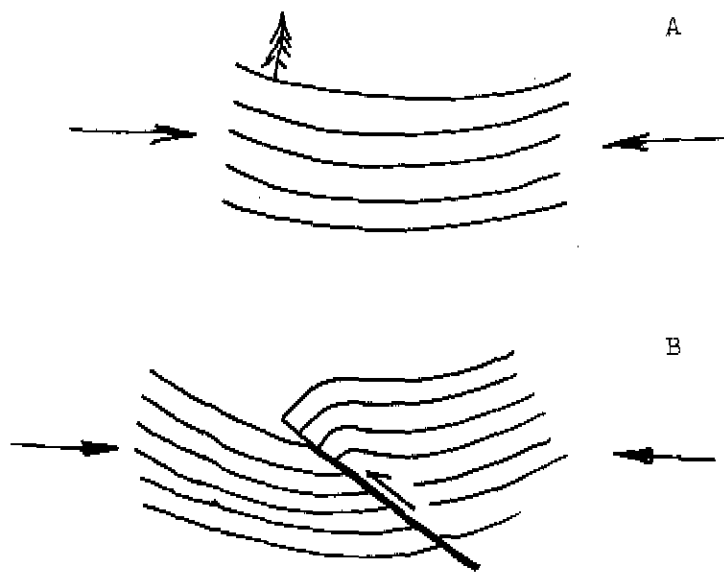
FER-138. Figure 7. Cartoon showing hypothetical way in which forescarp swales might form. (A) Terrace is gradually warped due to regional compression, until faulting occurs (B). Subsequent to faulting the forescarp swale would tend to fill with debris derived from the tilted terrace surface and the scarp.
